EVALUATION OF INNOVATIVE SAFETY TREATMENTS

Volume 5: A Study of the Effectiveness of Countdown Pedestrian Signals

Florida Department of Transportation

HNTB Corporation

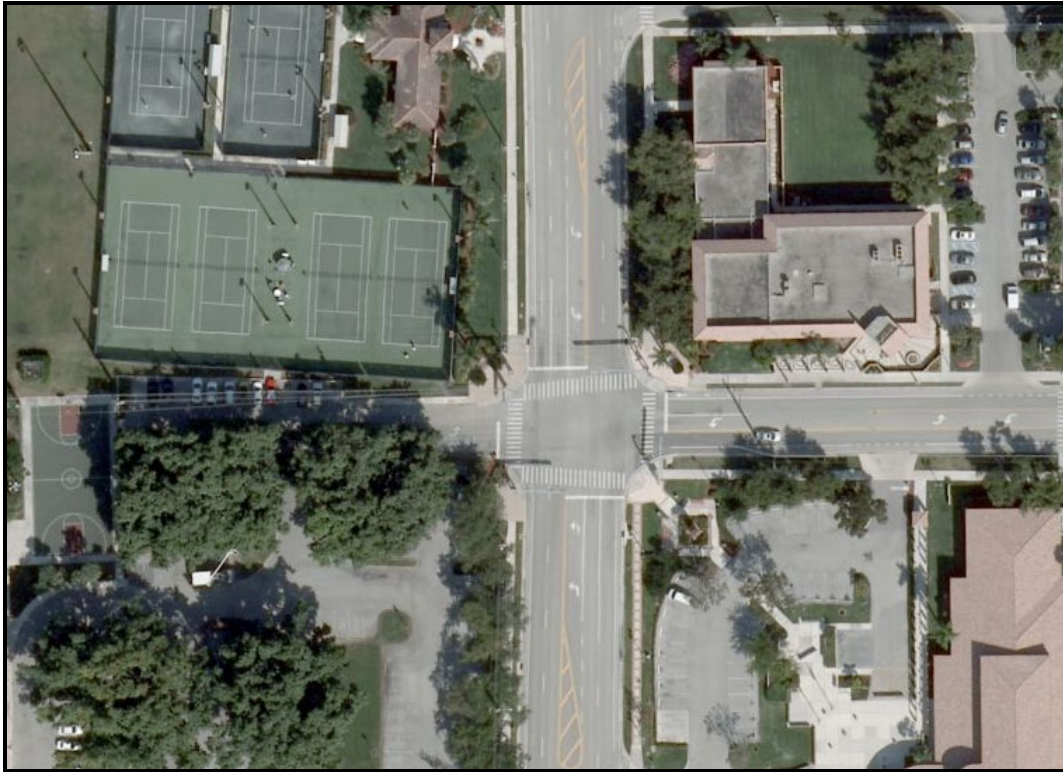
Figure 1. Study Intersection Aerial Photographs (Source: <http://maps.live.com>)

Oakland Park Boulevard at NW 55th Avenue
